DEPARTMENT OF TRANSPORTATION**DIVISION OF ENGINEERING SERVICES**

Quality Assurance and Source Inspection

Contract #: 04-0120F4Cty: SF/ALA Rte: 80 PM: 13.2/13.9File #: 69.28**WELDING INSPECTION REPORT****Resident Engineer:**Pursell, Gary**Address:** 333 Burma Road**City:** Oakland, CA 94607**Report No:** WIR-007481**Date Inspected:** 08-Jun-2009**Project Name:** SAS Superstructure**OSM Arrival Time:** 645**Prime Contractor:** American Bridge/Fluor Enterprises, a JV**OSM Departure Time:** 1845**Contractor:** Zhenhua Port Machinery Company, Ltd (ZPMC), Changxing Island **Location:** Shanghai ,China**CWI Name:** Li Yan Hua**CWI Present:** Yes No**Inspected CWI report:** Yes No N/A**Rod Oven in Use:** Yes No N/A**Electrode to specification:** Yes No N/A**Weld Procedures Followed:** Yes No N/A**Qualified Welders:** Yes No N/A**Verified Joint Fit-up:** Yes No N/A**Approved Drawings:** Yes No N/A**Approved WPS:** Yes No N/A**Delayed / Cancelled:** Yes No N/A**Bridge No:** 34-0006**Component:** OBG Assembly**Summary of Items Observed:**

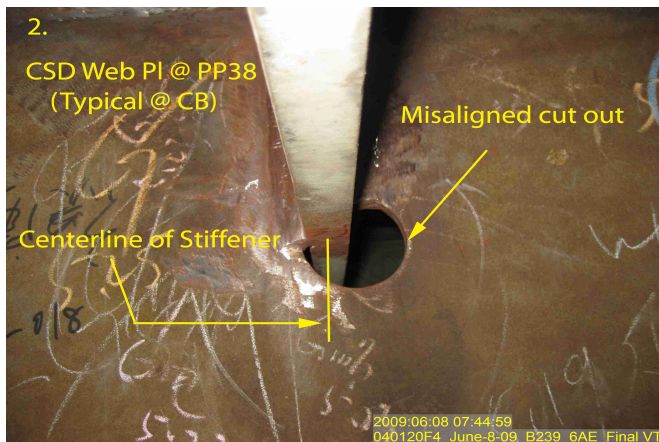
1.The connecting angle plates, for the T-rib to floor beam web bolted connection were found to be misaligned in a total of nine (36) locations throughout the segment. The misalignment was measured to be between 5mm to 15mm and occurs from panel point 37 thru 40.

2.The radius cut outs for the deck panel rib stiffeners were found to be misaligned in way of corner segment assembly at panel points 37 thru 40.
